RD pile retaining walls Korsvägen station: Predictions versus monitoring

Thomas Kasper, COWI A/S, Denmark

Västlänken E05 Korsvägen design & build contract: NCC and Wayss & Freytag Ingenieurbau JV with COWI A/S as main designer

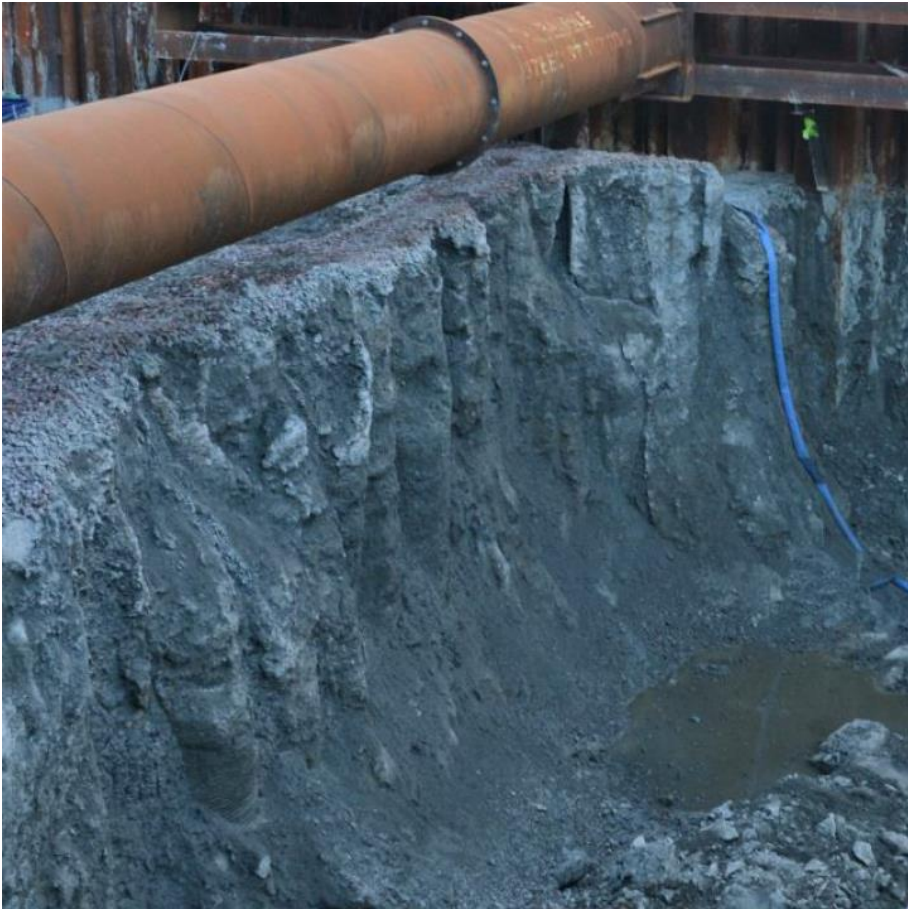
Ø800 mm LC-COLUMN

Lime cement (LC) block stabilization of the whole excavation volume:

- Increase passive resistance – reduce wall deflections and optimize retaining wall system
- Ease excavation and muck handling / transport
- 40 kg/m³ 30/70 % lime/cement binder type for RD piles

Clay at Korsvägen station:	Sensitivity	20 -150
	$C_{u,active}$ (kPa)	25 – 33
	w_N (%)	75

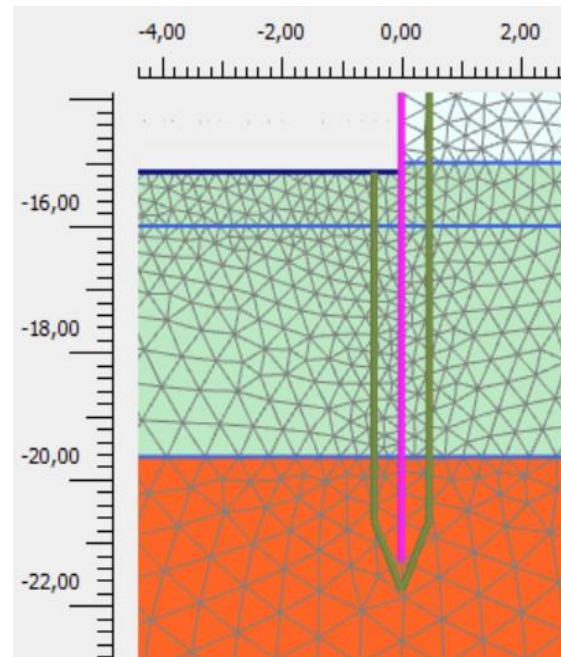
Toe support

SSAB's RD pile manual proposes low toe rotational stiffness for 3 diameter rock embedment length. 2 diameter embedment was chosen to minimise rock drilling.

- > Design was therefore based on calculations both:
 - Without toe rotational restraint (simple horizontal toe support)
 - With toe rotational restraint (embedment modelling)

Without toe rotational restraint

With toe rotational restraint

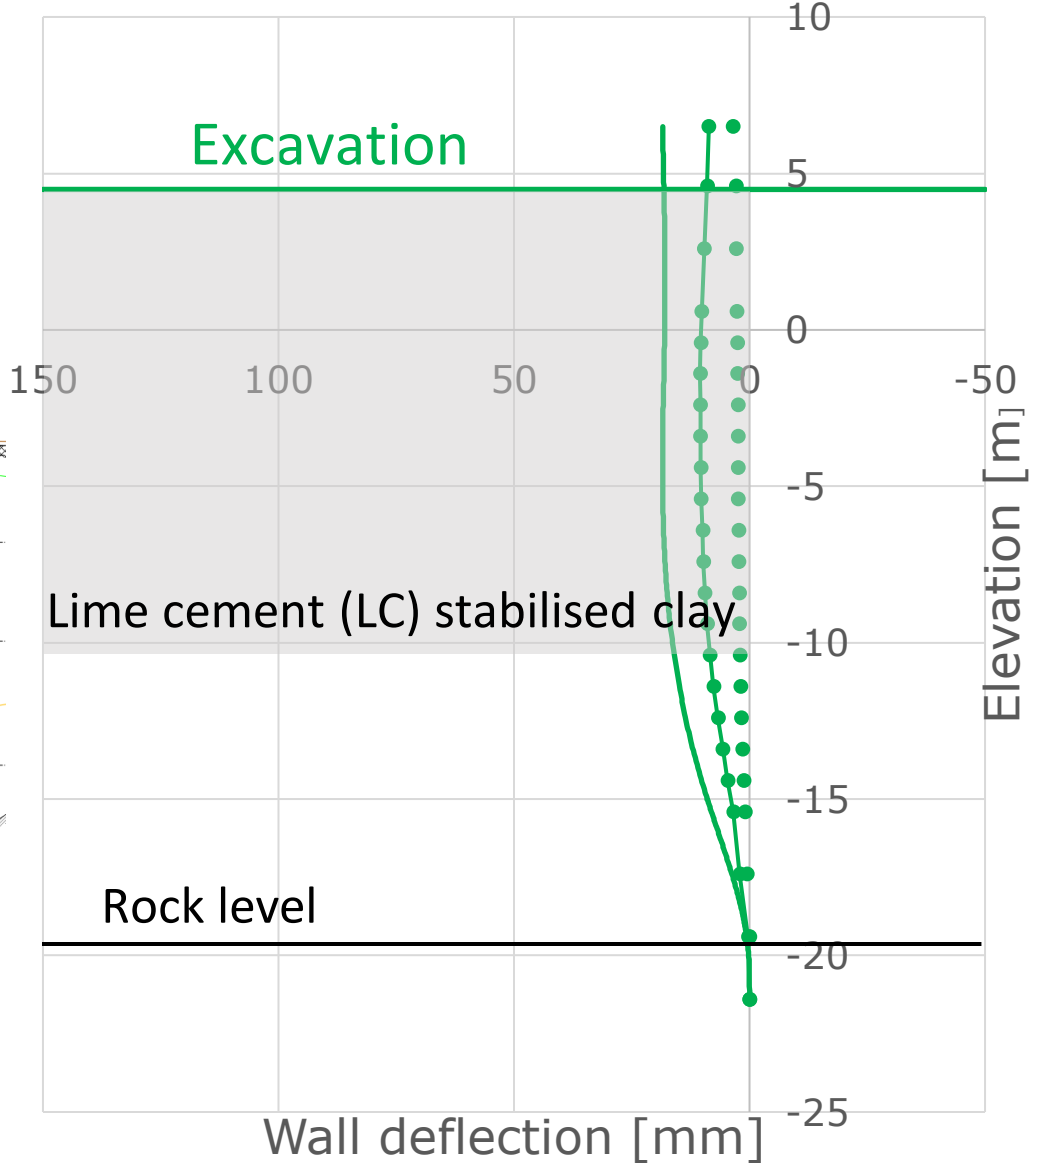
First excavation:

- 20 mm wall deflection (uniform compression of the LC block) calculated
- 3 mm deflection measured after excavation, increasing to 10 mm after strut installation

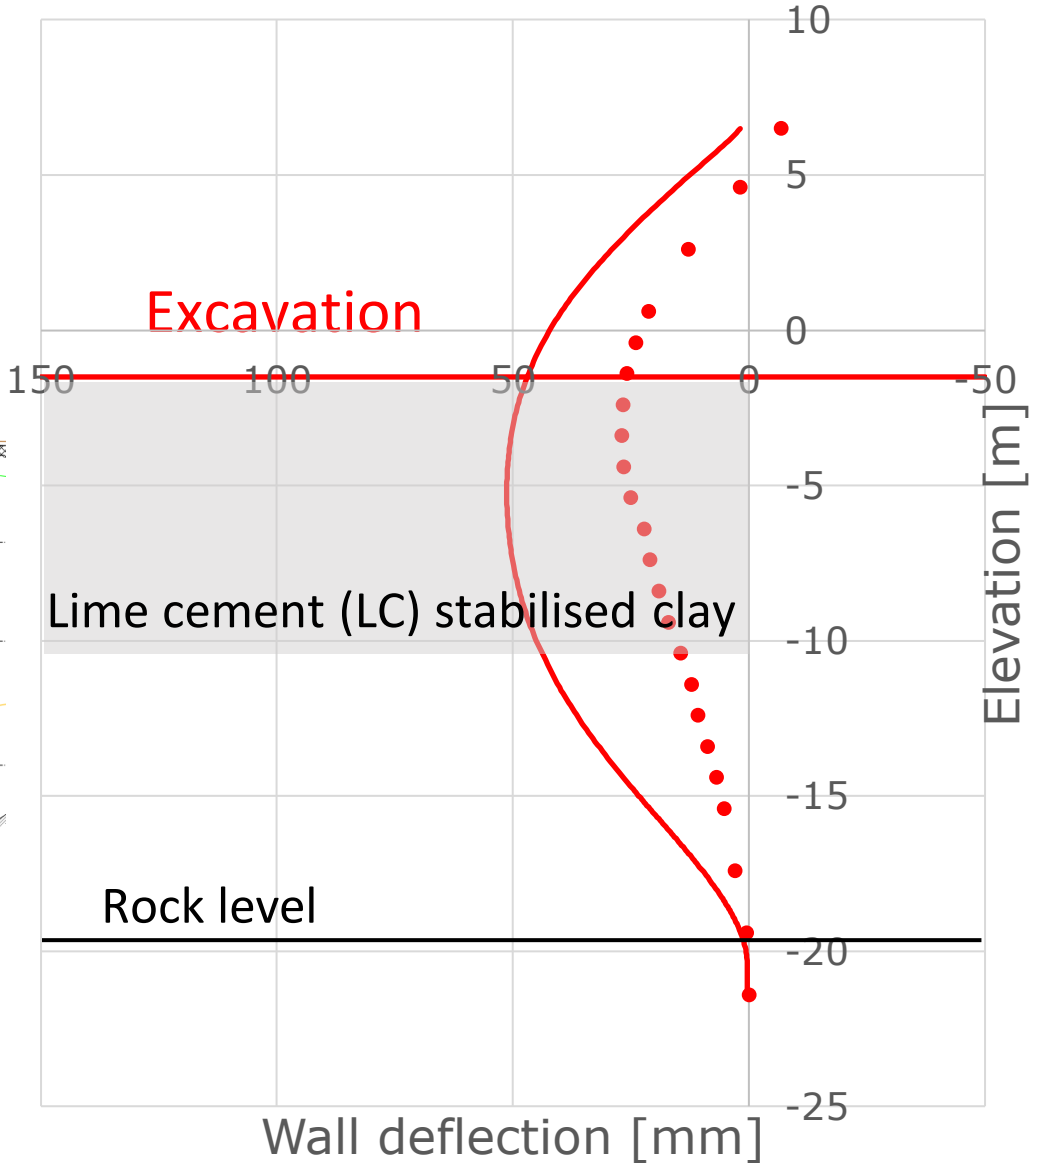
Excavation to second strut level:

- 30 mm measured until end of excavation

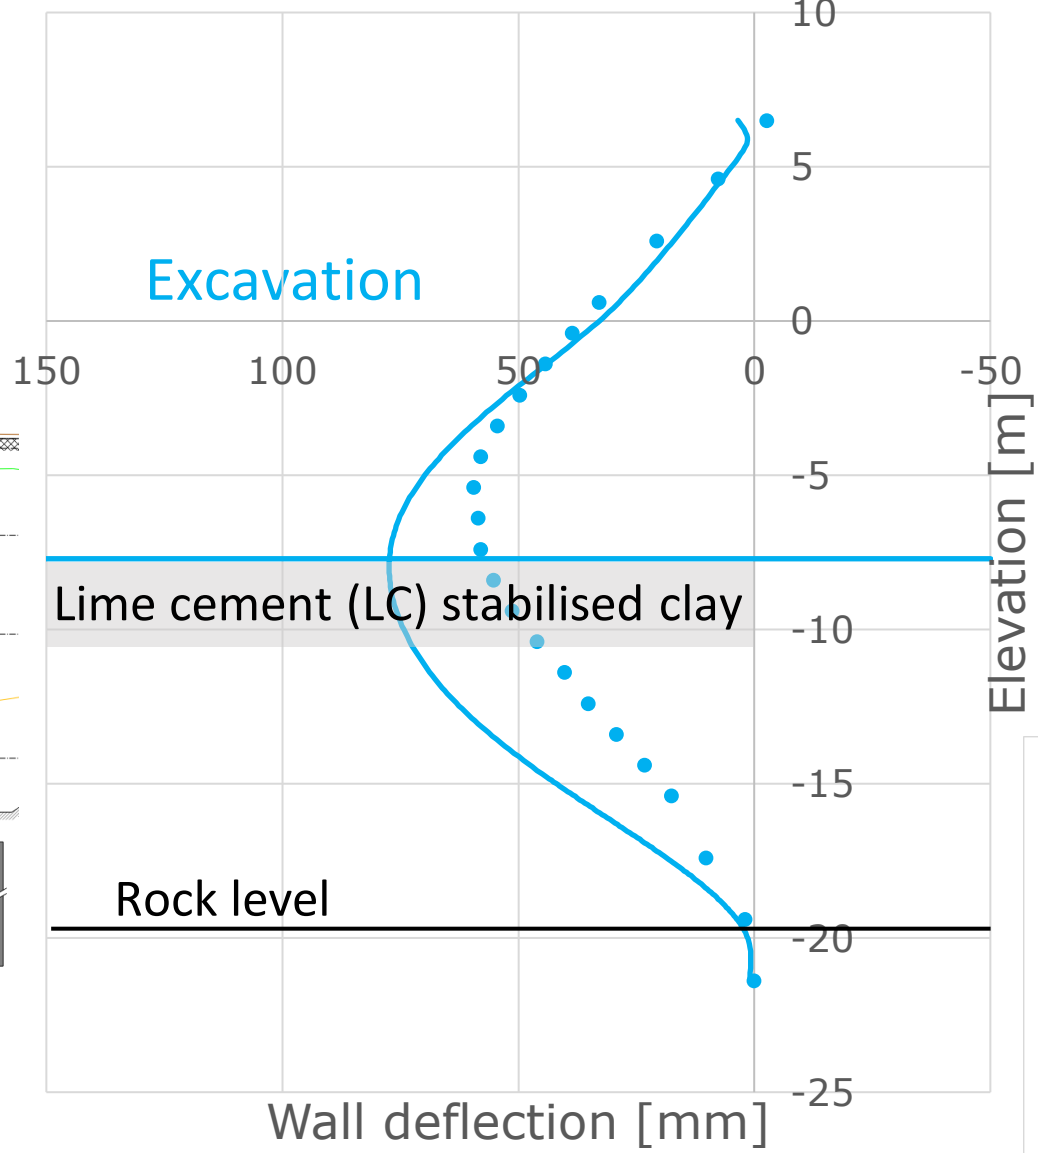
Excavation to third strut level:

- 20 mm additional measured deflection until end of excavation

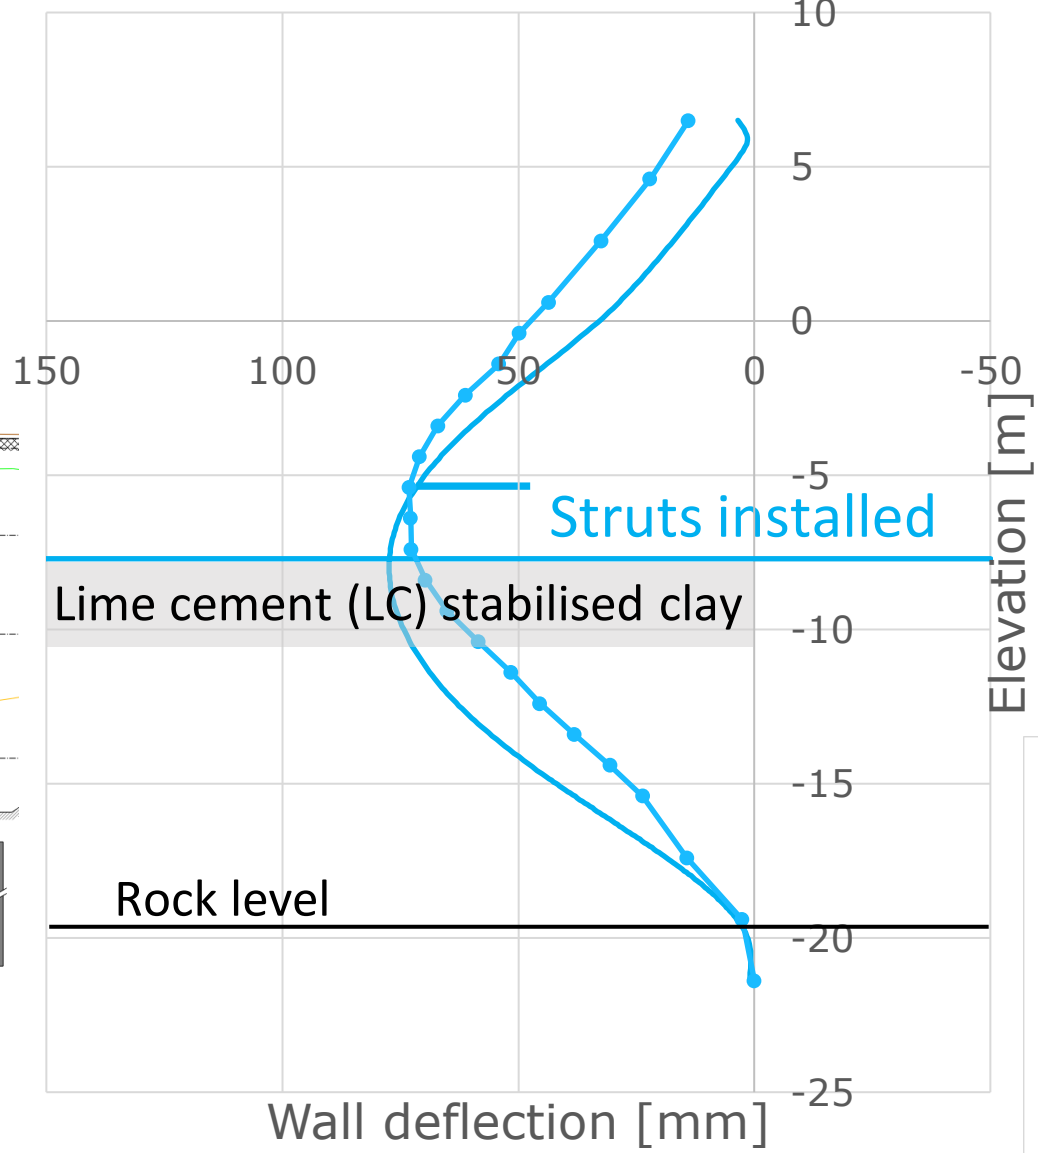
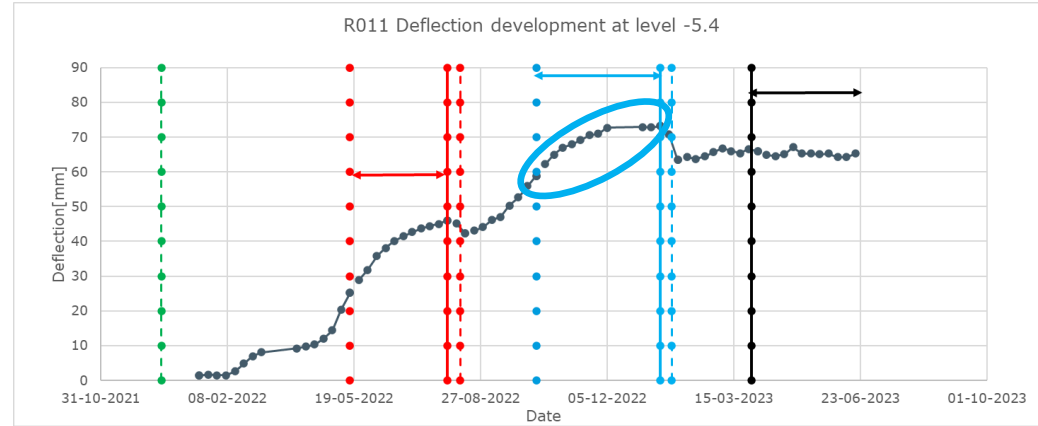
Third strut level installed over a 3 months period:

- 15 mm additional measured deflection due to LC stabilised clay consolidation
- Additional deflection at strut level 1 & 2 due to temperature effects and northwards deflection of both north and south wall

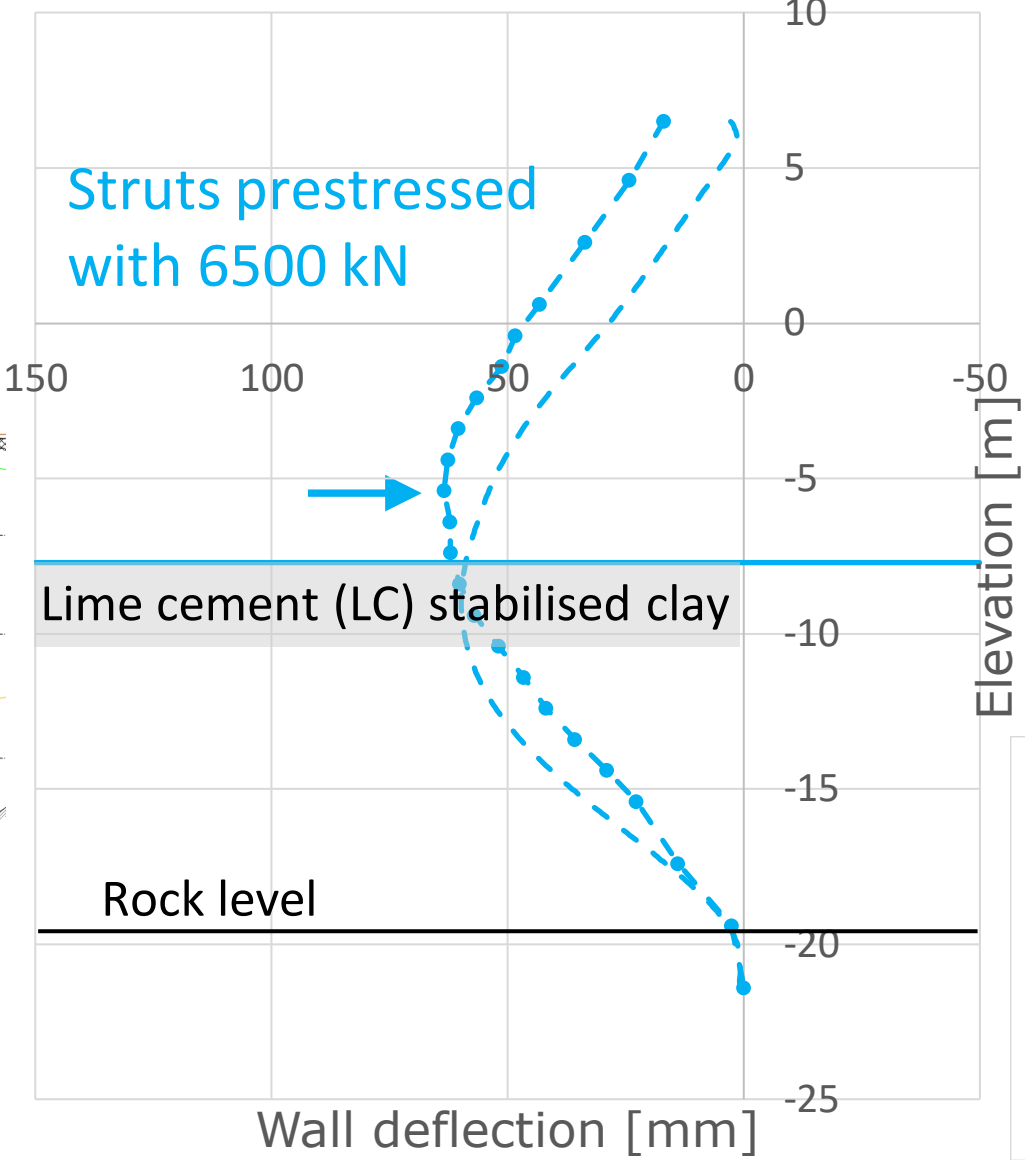
Struts prestressed with 6500 kN

Third strut level prestressed:

- Measured backwards deflection smaller than calculated -> soil stiffness higher than assumed

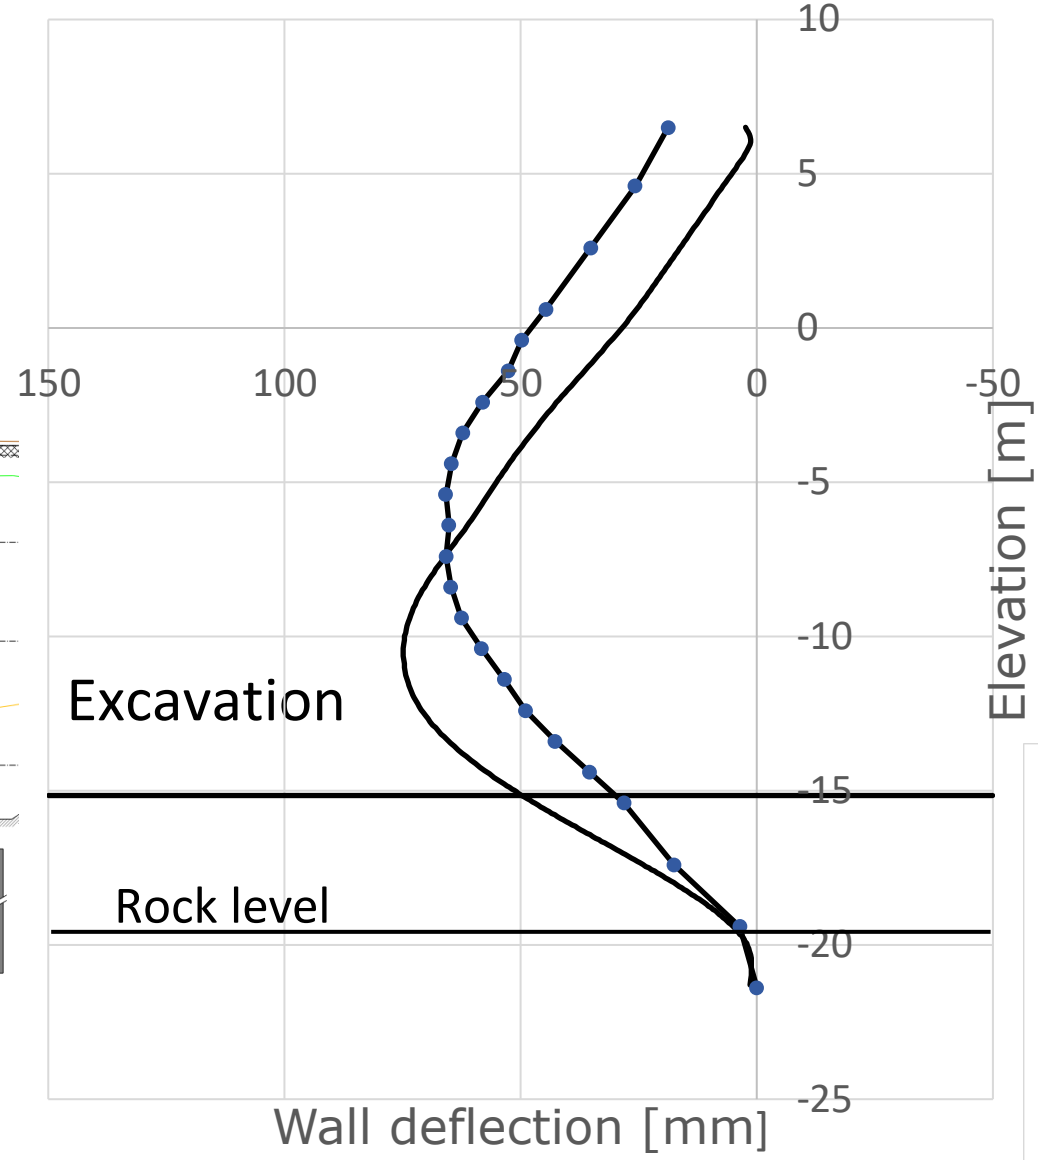
Final excavation:

- Only slight increase in measured wall deflection in lower part of wall.

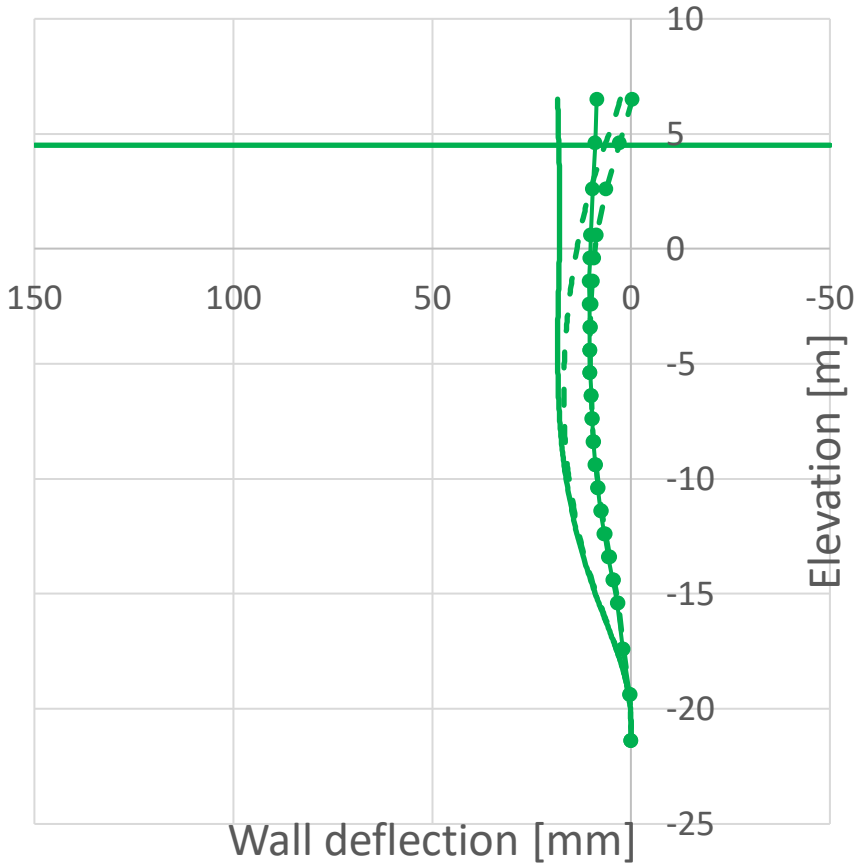
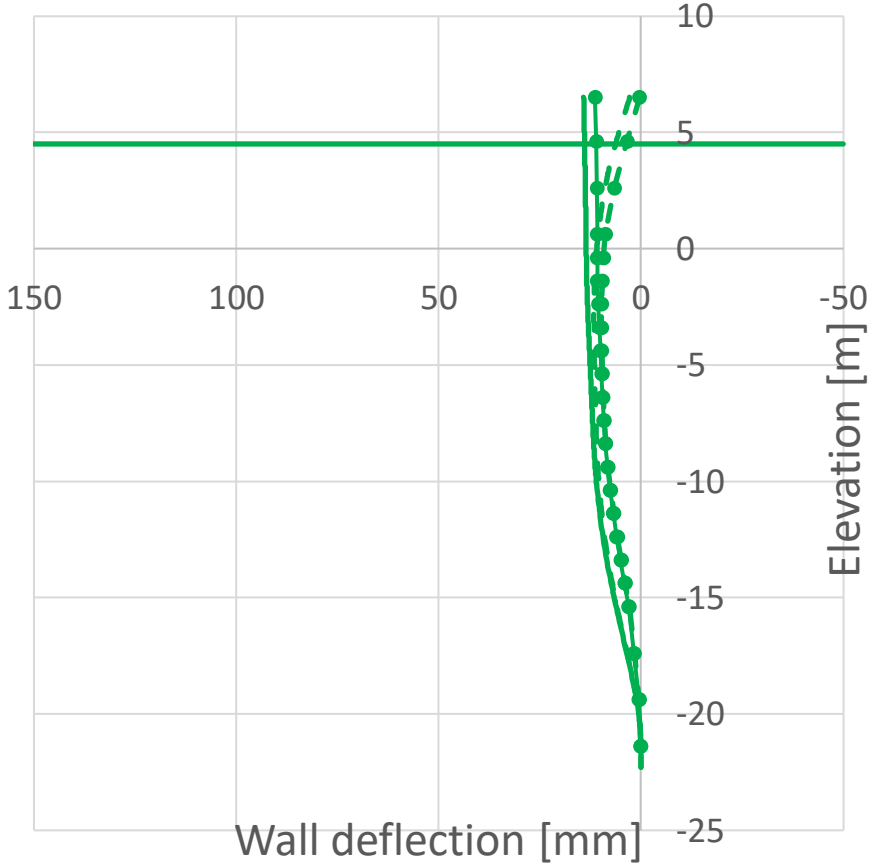
Original Comparison

Back Analysis

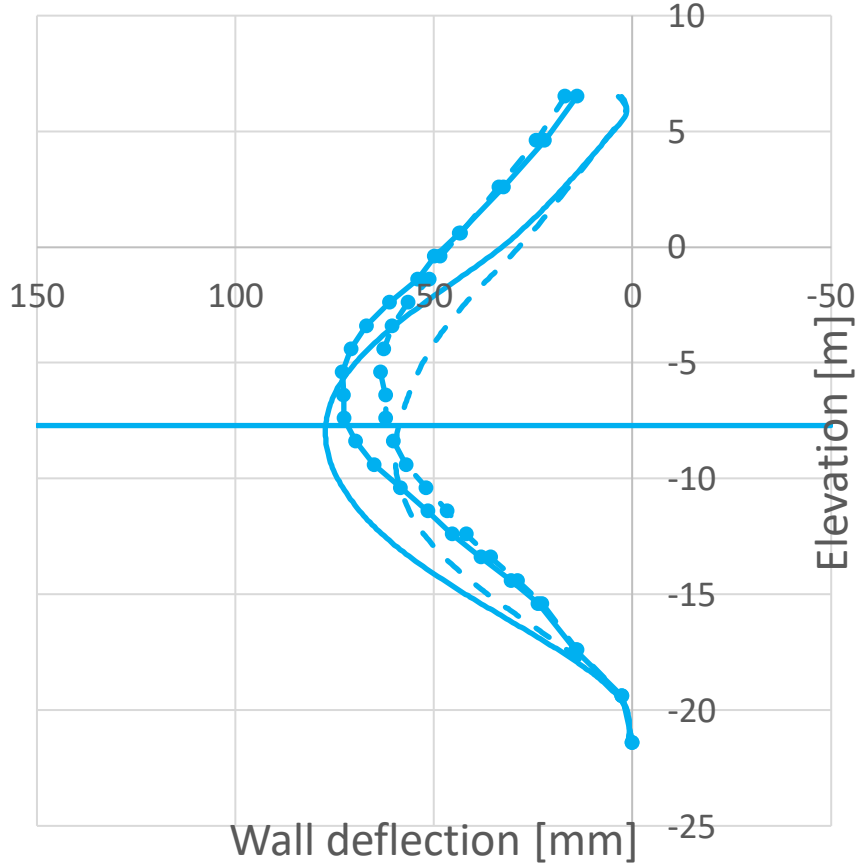
Original Comparison

Back Analysis

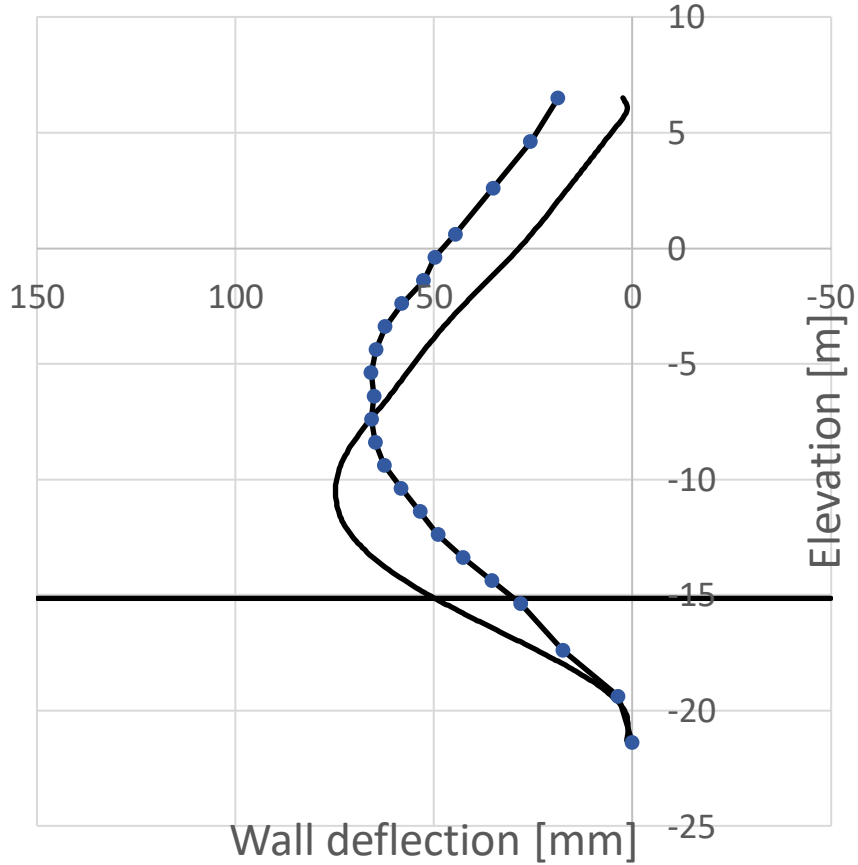
Original Comparison

Back Analysis
